## QUINQUENNIAL INSPECTION REPORT

NAME OF CHURCH	ST MARY THE VIRGIN - COLTON
DIOCESE	LICHFIELD
ARCHDEACONRY	LICHFIELD
PRIEST IN CHARGE	REV SIMON DAVIES
CHURCH WARDENS	KATIE BROWN & JOANNA LOWE
PROFESSIONAL ADVISOR	RONNIE CRUWYS & STEPHEN HART
ADDRESS	HORSLEY HUBER ARCHITECTS LTD CASTLEBERG STUDIOS 134 NEWPORT ROAD STAFFORD ST16 2HB  Tel: 01785 251238 Fax: 01785 257843 Email: Stafford@hhastudio.com
DATE OF INSPECTION	10 <sup>th</sup> July 2007
DATE OF PREVIOUS INSPECTION	2002 carried out by Joe Huber
WEATHER CONDITIONS	Warm, cloudy, generally dry

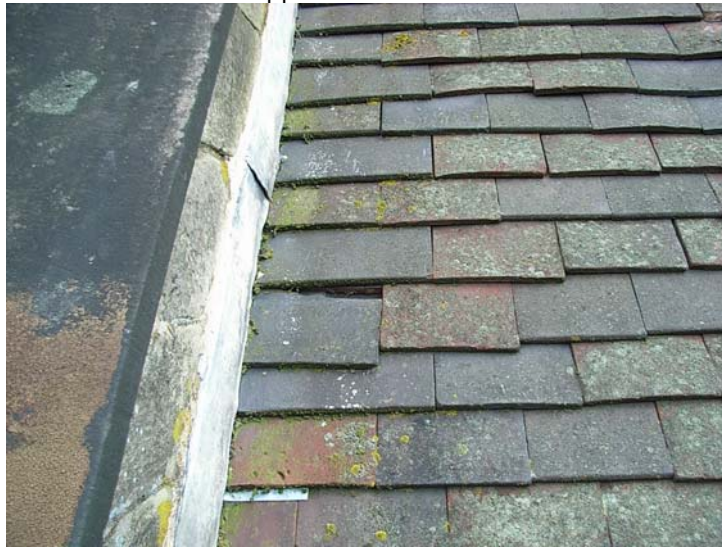
- 3.1 The roof coverings of the church are generally in very good condition. The whole building was re-roofed relatively recently and as you would expect is in good condition.
- 3.2 There are a few noticeable exceptions. The north side of the chancel roof, although generally good, does have one or two slipped and shaled tiles which should be replaced.

*3.2 Slipped tiles*

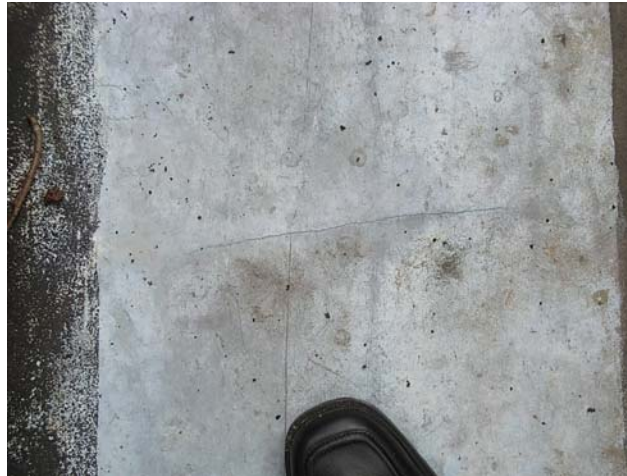
- 3.8 The valley gutter between the Vestry and the Chancel (which is slightly narrow with it being lower down the roof) is not sub-divided into bays with wooden rolls and unfortunately there is some cracking in the lead. I don't think it leaks yet but this needs to be a priority repair.

3.8 Signs of lead cracking

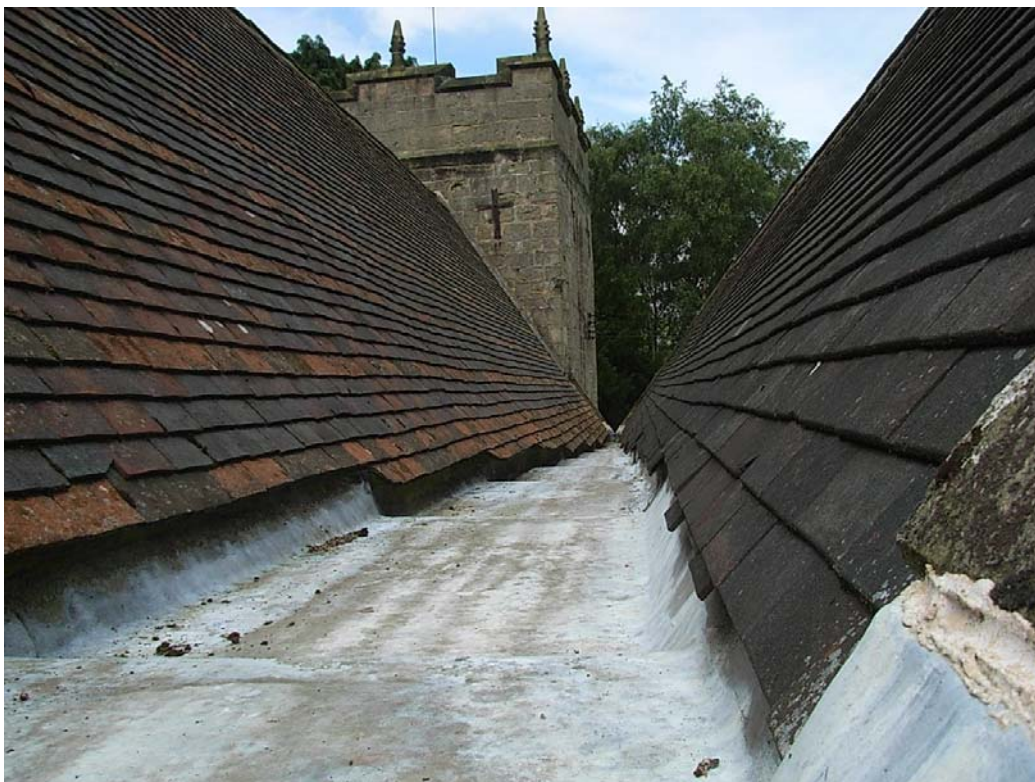
- 3.9 The south of the north aisle roof drains into a valley gutter which also abuts the nave roof. There are a few slipped tiles along the bottom edge; a lot of these have been put straight as a holding exercise but it might be worth considering removing these, renewing the tiling battens, possibly with spacers to kick them up slightly, and then replacing the roof tiles. There is no sign of water ingress at present, they just leave a slightly untidy appearance at the edge of the roof. This isn't essential work but it will need to be done in the future.

3.9 Slipped tiles on valley gutter

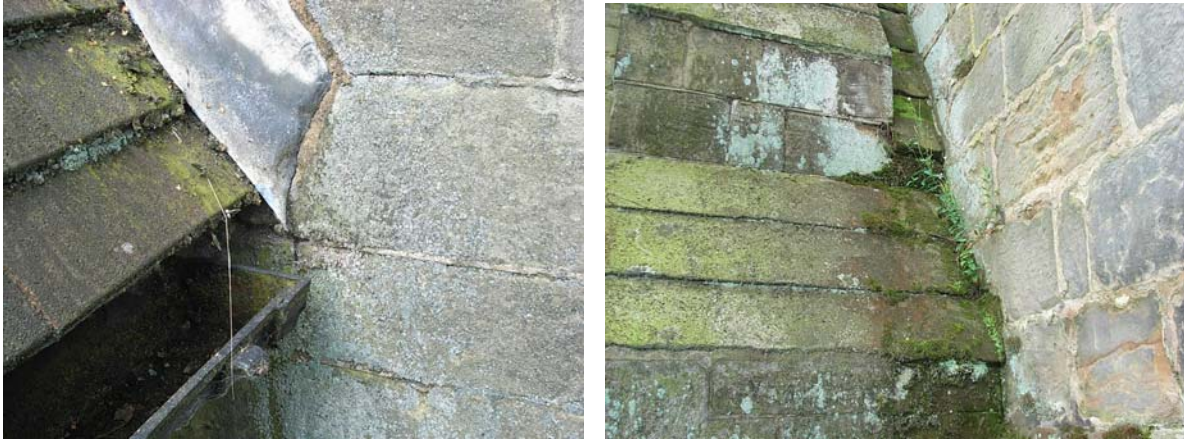
- 3.10 At the edge of the chancel roof, where it abuts the east wall of the north aisle, there is evidence that water runs down the very edge of the roof and then down the wall, missing the gutter. This could easily be remedied by inserting a small lead flashing to direct the water into the gutter and not down the stonework. This should be done as a priority.

*3.10 Water missing the gutter*

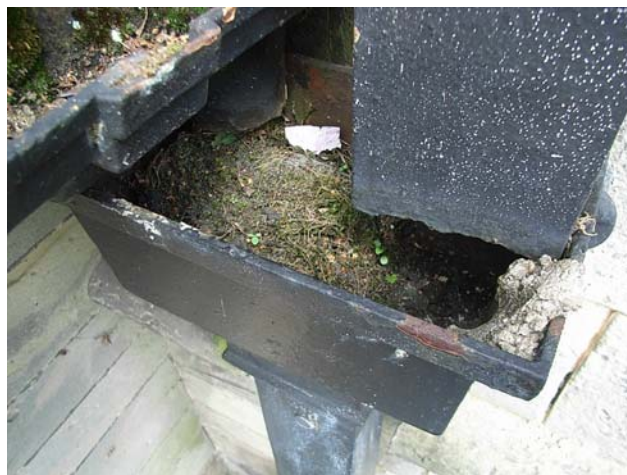
- 4.1 To the North side of the chancel there are two rectangular section rainwater pipes. The gutters are clear and in good condition. However, both shoes of the down pipes are wet indicating that there is a blockage in the pipe. Both of these need to be unblocked. (this has since been done).
- 4.2 The outlet from the valley between the chancel and the Vestry appears to be clear.
- 4.3 The downpipe adjacent to the porch roof is also apparently blocked (this has since been unblocked).

*4.3 Blocked outlet*

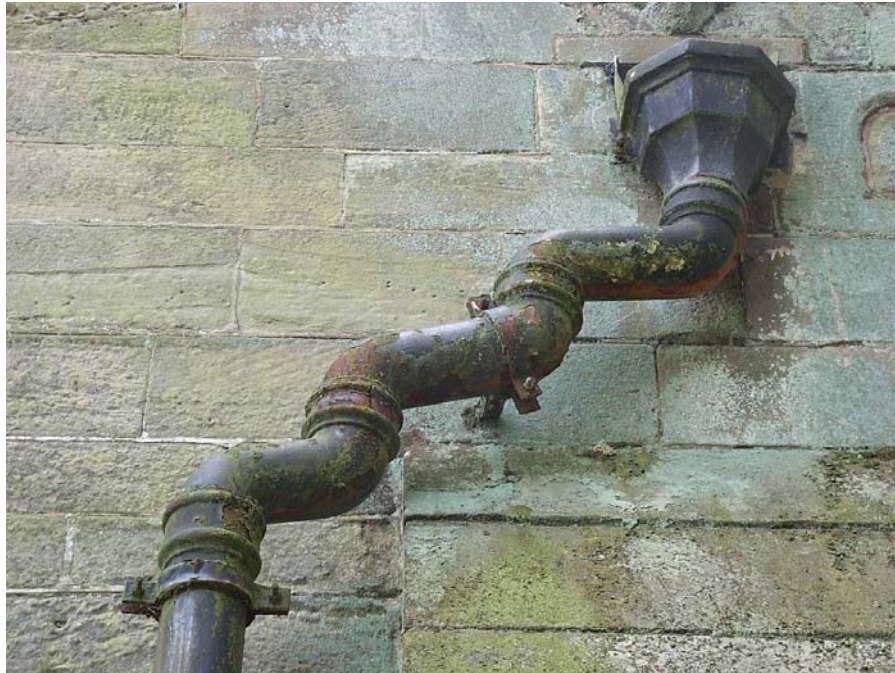
- 4.5 The rainwater pipe that discharges from the central valley gutter between the north aisle and the nave is cast iron and has a rather convoluted swan neck arrangement at the top. This has recently been unblocked, but I can see that some of the collars on the top of the rainwater pipe and the first swan neck are cracked. I think it would be work replacing these with a simplified single swan neck arrangement to reduce the risk of blockage.

*4.5 Swan neck*

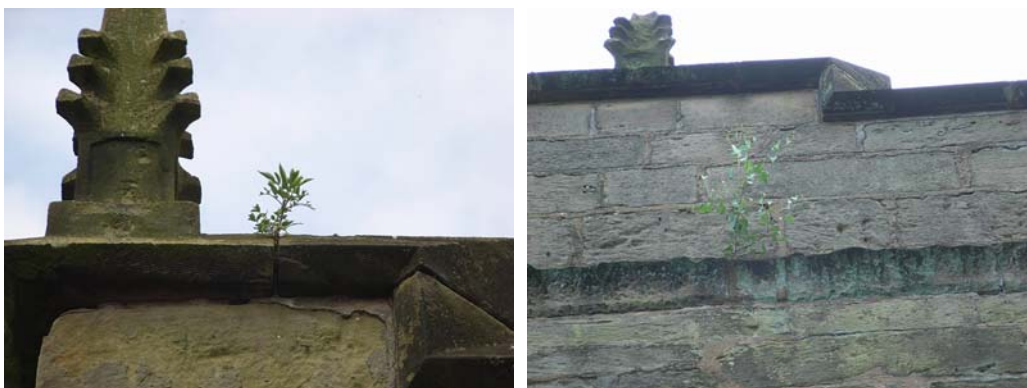
- 6.1 The parapets on the south side of the tower roof are a robust section, at least 8" thick and are generally in good condition. They are surmounted by eight pinnacles, one at each corner, and one at the mid point of each side. The central one on the east side has recently been rebuilt using the same stone after it fell off in gales last year. The weather vane in the centre of the roof also appears to be in good condition.
- 6.2 Some of the joints in some of the parapets are open and there is an elderberry bush growing on the south east corner. This needs to be raked out properly to the full depth and re-pointed and the roots of the elderberry bush removed.

*6.2 Vegetation growing in mortar joints*

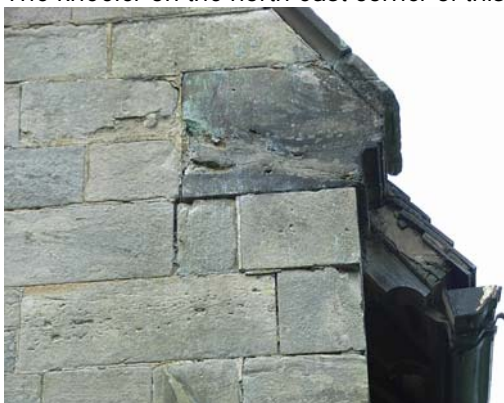
- 7.1 Starting on the north aisle: the stonework on this elevation is a fine jointed ashlar, in a grey sandstone and appears generally to be in very good condition. A small amount of pointing may be necessary on the north west buttress, but elsewhere the pointing appears to be good.
- 7.2 The kneeler on the north east corner of this part of the building appears to be misaligned slightly.

*7.2 Kneeler misaligned*

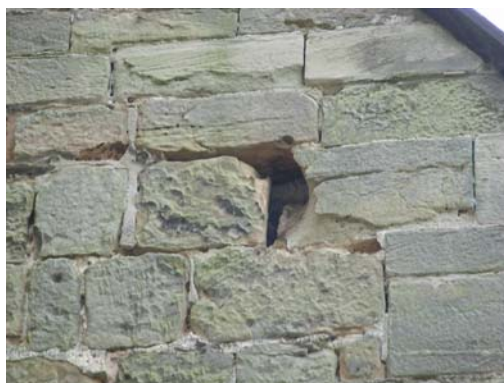
*7.10 Hole in masonry near apex*

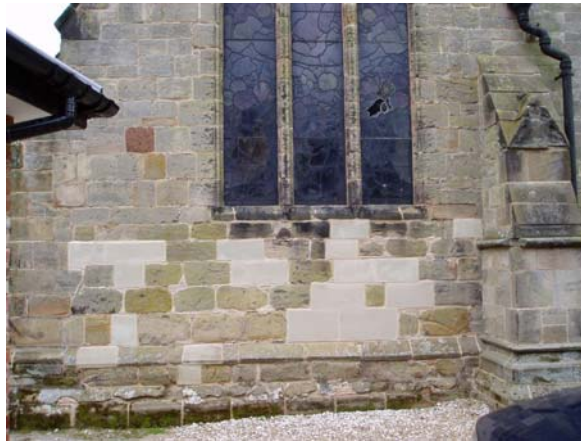
*7.6 Recent repairs*

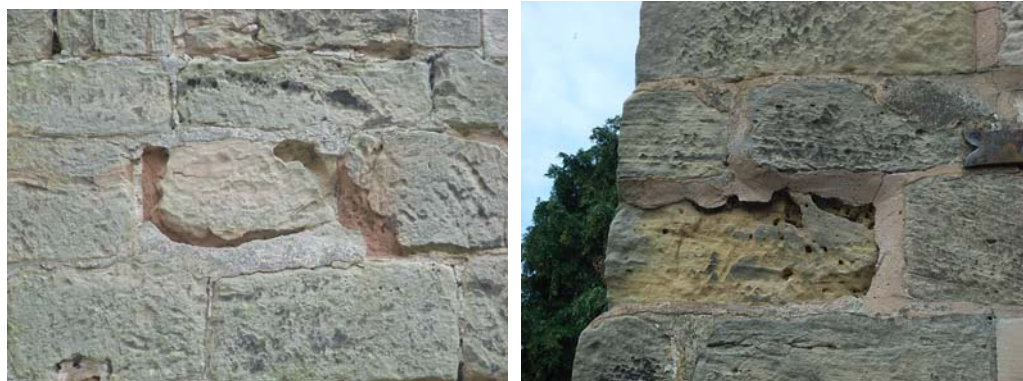
- 7.9 The stonework to the porch is slightly weathered but is generally sound.
- 7.10 The stone work to the west gable of the south aisle is of ancient stone and there are a number of open joints in this area, particularly from the eaves upwards. There is a sizeable hole towards the apex. A couple of other stones have been badly damaged by weather and also by masonry bees. This elevation will need attention in the not too distant future.

*7.10 Damage by masonry bees*

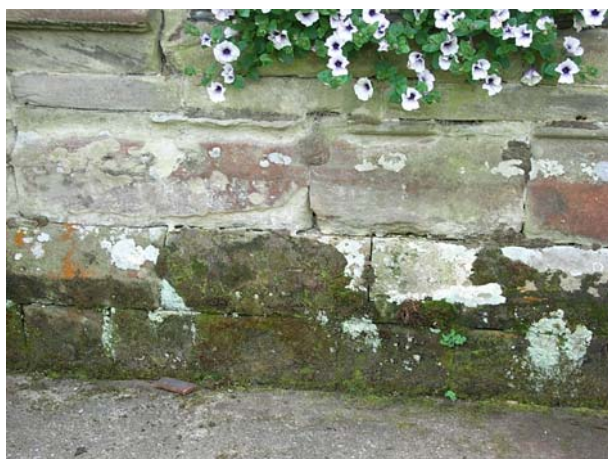
*7.13 Open joints in plinth*

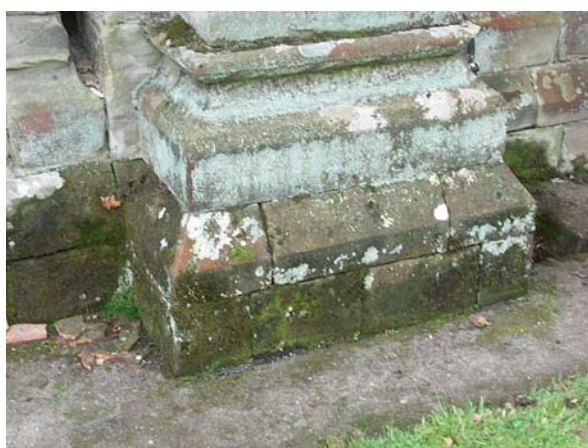
- 7.8 South side of the south aisle – this is again part of the GE Street building and is in generally good condition. The pointing is reasonable, probably not requiring attention immediately. Perhaps in the next five years, a couple of the buttresses could do with being raked out and re-pointed.

*7.8 Buttress showing open joints*

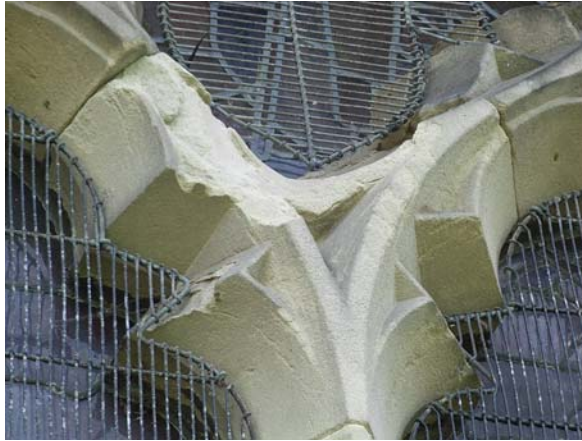
- 9.4 The south elevation of the Chancel: the eastern-most window on this elevation is again protected by a mesh protection which is generally in good condition. However, some of the stone has spalled slightly, both on the central 'Y' section of tracery and on the window cill of the left hand light. I wouldn't recommend any attention for the time being but the central 'Y' section will eventually need to be replaced.

*9.4 Eroded 'Y' section of tracery*

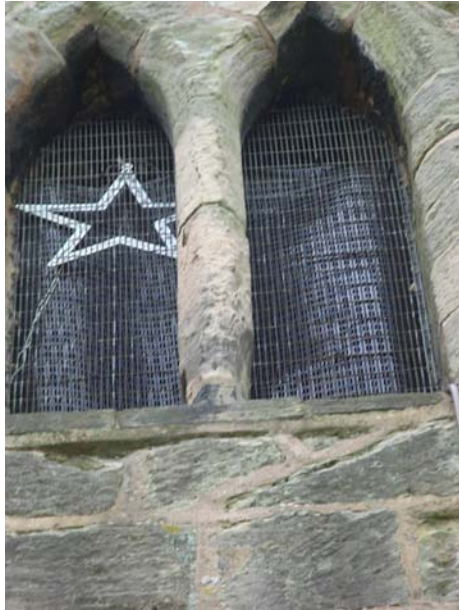
- 9.12 On the north facing bell lancet that has a central mullion, the lower section is quite eroded. It isn't essential at the moment but it should be replaced in the not too distant future.

*9.12 Eroded stone at bottom of mullion*

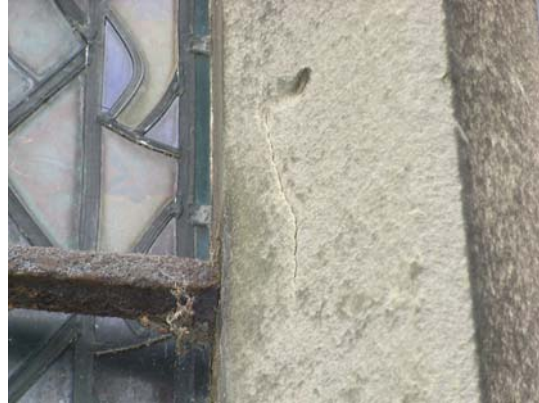
- 9.11 The west facing window of the north aisle has two lights and again external ferramenta. This is corroding and is leading to the stonework in the central mullion and to the right hand jamb cracking. The ferramenta needs to be rubbed down and repainted.

*9.11 external ferramenta to be painted*

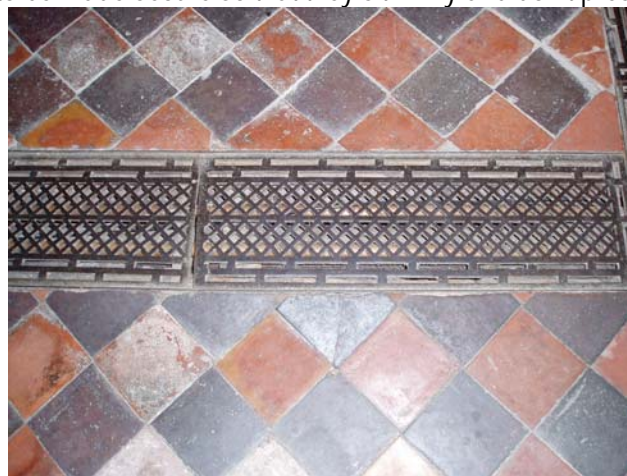
16.5 The grille ducts are also quite loose in places and do not lie level with the floor, some are raised. These do need to be made secure so that they sit firmly and don't present a trip hazard.

*16.5 Loose grille ducts*

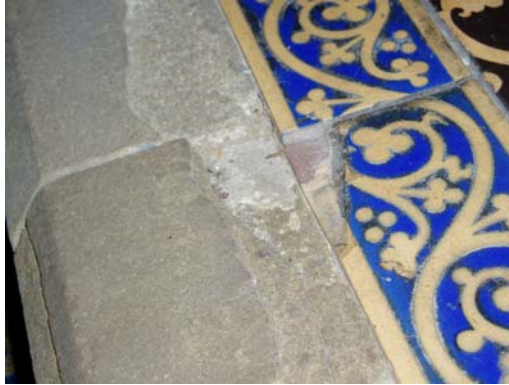
*16.10 Vulnerable tile*

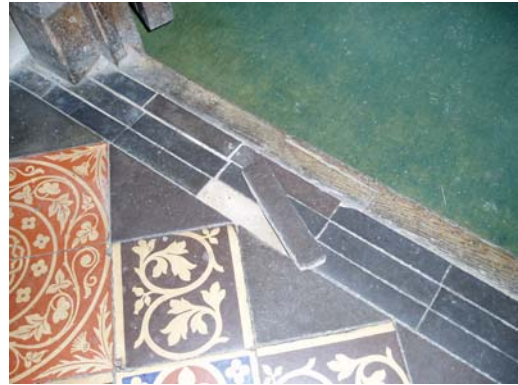
*16.11 Loose tile slips by step down to vestry*

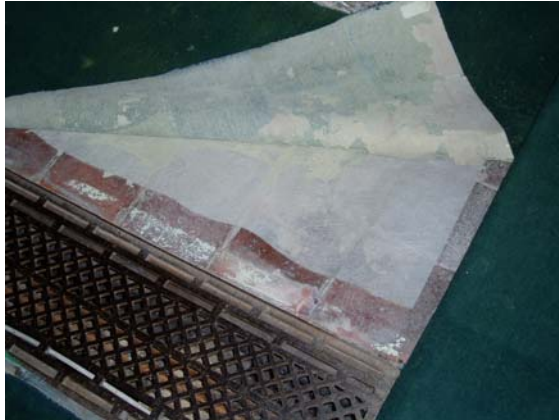
- 16.13 Elsewhere the carpet was not lifted so I cannot fully check the condition of the floor in here. However, be careful around the edges of the ducts as the carpet is quite loose and it presents a trip hazard. The carpet is foam backed and it is perishing underneath.

*Carpet backing starting to perish*

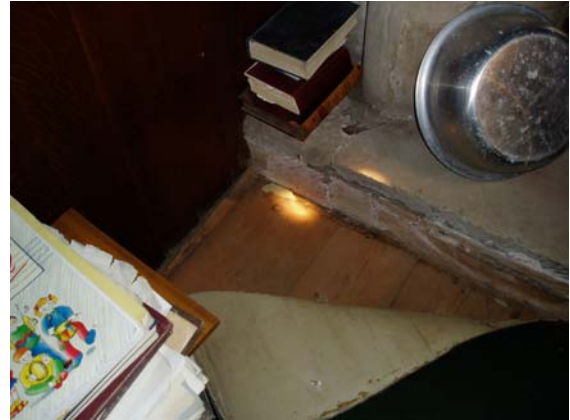
*16.14 Floor springy – check here*

- 16.14 There is a single step up to a timber platform below the organ. There is one area in the corner quite close to the column which feels very springy underfoot. I think the joist underneath has gone. This needs a joiner to lift the carpet and the boards and have a look underneath and build up the level to make it secure just here.

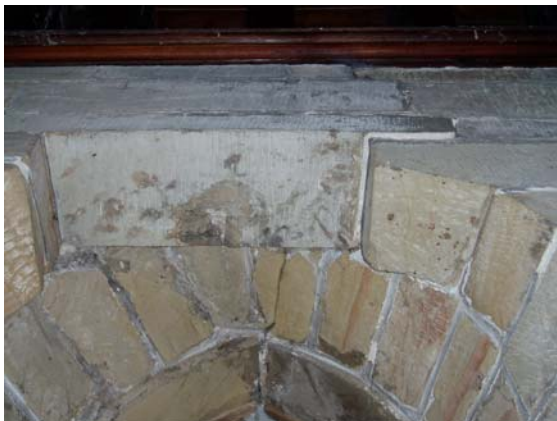
- 17.1 On the south wall of the vestry, directly above the single lancet window closest to the east wall, there is a crack to the side of the lintel, going up two stone courses. The crack has gone through one of the key stones and opened the mortar at the head of the window. The stones have been pushed proud of the adjacent wall by about 1cm. I would recommend putting some 'tell-tales' up here and monitoring the movement.

*Crack above window in vestry*

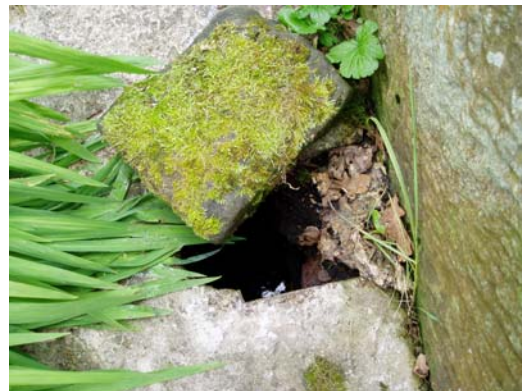
*Loose stone*

31.2 There is another loose stone which forms a boundary to the bedding just to the side of the bench dedicated to George Upton. This has fallen over. I have just put it back in place, but it is a little bit loose and you may need to just re-secure it.

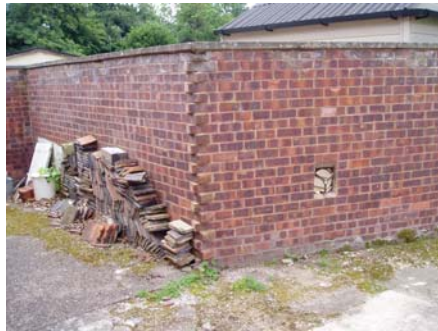
34.1 The boundary fence consists of timber posts and barbed wire; these are all well secured and in good order. To the eastern boundary, a wooden flat boarded fence, approximately two metres high, borders the adjacent rectory, also in good condition. The fence meets a brick wall –still the boundary with the neighbouring property. There is some wear and tear to the top of the wall where the bricks have started to spall and the copings are a little loose. This will need some repair within the next 5 years.

*Wall where copings are loose*

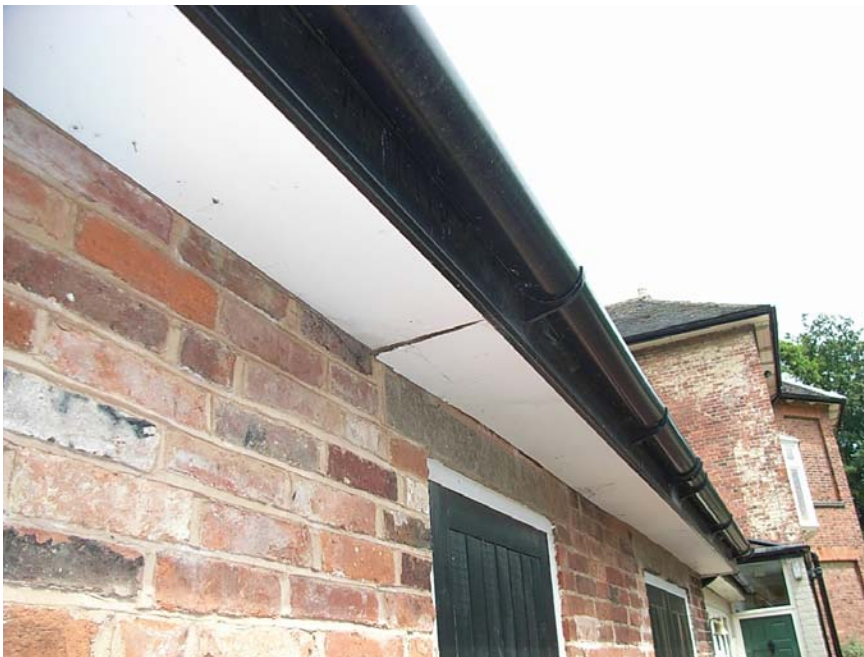
- 37.3 The roof is finished using plain clay tiles with a bull nose ridge at the top.
- 37.4 The rainwater goods are of UPVC with UPVC 75mm diameter rainwater pipes that discharge into gullies. Both the rainwater goods and the below ground drainage appears to be in good condition.
- 37.5 The walling of the building is of a red/orange brick and the mortar joints appear to have been recently re-pointed, all appears to be in good condition.
- 37.6 I could see no evidence of air bricks despite the fact that there is a suspended timber floor inside.
- 37.7 The fascias of the building are of black painted softwood, and the soffits are of white painted plywood. Around the back, the soffit appears to have dropped and needs to be re-fixed before it falls off.

Dropping soffit.
