## QUINQUENNIAL INSPECTION REPORT

NAME OF CHURCH	ST MARY THE VIRGIN - COLTON
DIOCESE	LICHFIELD
ARCHDEACONRY	LICHFIELD
PRIEST IN CHARGE	REV SIMON DAVIES
CHURCH WARDENS	KATIE BROWN & JOANNA LOWE
PROFESSIONAL ADVISOR	RONNIE CRUWYS & STEPHEN HART
ADDRESS	HORSLEY HUBER ARCHITECTS LTD CASTLEBERG STUDIOS 134 NEWPORT ROAD STAFFORD ST16 2HB  Tel: 01785 251238 Fax: 01785 257843 Email: Stafford@hhastudio.com
DATE OF INSPECTION	10 <sup>th</sup> July 2007
DATE OF PREVIOUS INSPECTION	2002 carried out by Joe Huber
WEATHER CONDITIONS	Warm, cloudy, generally dry

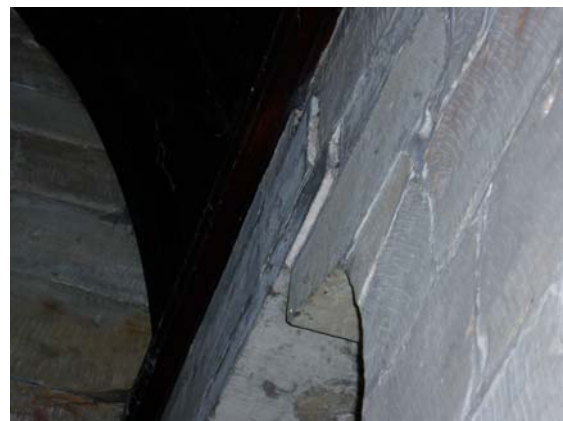
*Crack above window in vestry*

- 17.2 There is a hairline crack in the masonry down on the side of the internal window cill. At present there are some games tables placed in front and it is difficult to see it all from the bottom. However, from what I can see, there is no further sign of any cracks much below cill level.

- 17.3 However, on the eastern reveal of the window a crack is meandering its way from top to bottom and there has been some damage to the arched stone at the top. I suggest that some further 'tell-tales' are placed on these cracks and during the next quinquennial these are monitored for movement.

- 17.4 Externally there has been some masonry repair work which could have also contributed to the cracks here. Either way it is a vulnerable corner as vehicles can drive very close to the church. Otherwise, everything else seems to be in good order and there are no further open joints here.

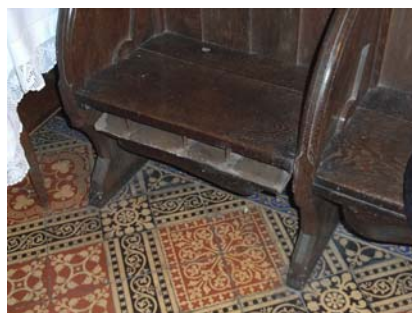
- 18.1 The choir stalls in the Chancel are in oak and are quite attractive though not particularly comfortable. They are shaped to face the altar just by the Chancel arch. One of these has a loose piece of wood which represents a mullion below tracery and needs to be refastened using a non-ferrous fixing such as brass, which won't react with the tannin in the oak. The oak choir stalls appear to be in good condition.

- 18.2 By the altar there are some misericords where a part of one is falling to pieces where the glue has dried on an exposed dowel. This needs to be repaired before it falls apart and the pieces are lost.

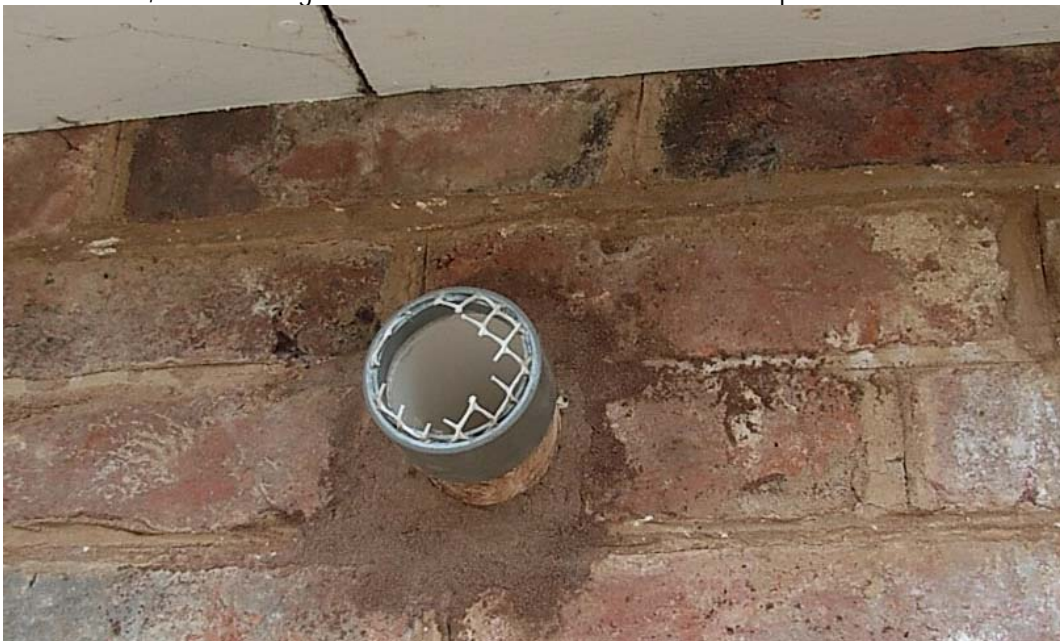
- 23.1 The heating is powered by a gas fired hot water system with panel radiators around the perimeter of the church and appears to be effective. This is also supplemented by the previous heating system of Quartz Ray electric filament lamps. These are useful in spring and autumn when these can be put on for a short amount of time to save firing up the main boiler.
- 23.2 Copper pipework extends around the perimeter of the church though there are places where the pipework is taken through the former heating ducts.
- 23.3 The boilers are located in the boiler room which is adjacent to the church and adjoins the neighbouring property. There are two outlets from these boilers which have plastic grilles to keep out the birds, these have gone brittle and broken and need to be replaced.

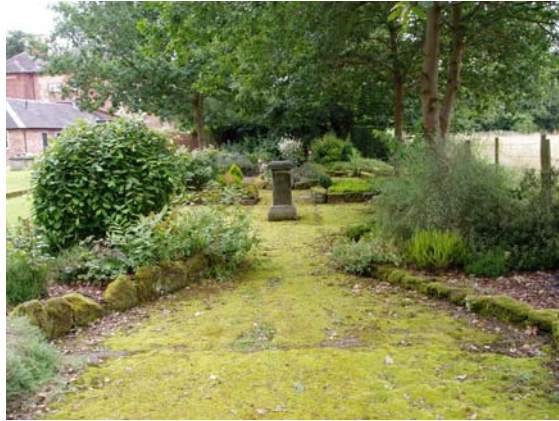
31.4 Between the garden and the lawn, just to the side of the sundial stone, I have repositioned a stone which covers a hole which leads down to a well. You may be better with a slightly larger, heavier stone which isn't dislodged so easily.

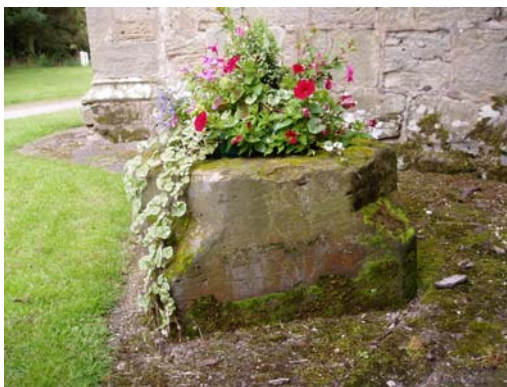
*Font as planter*

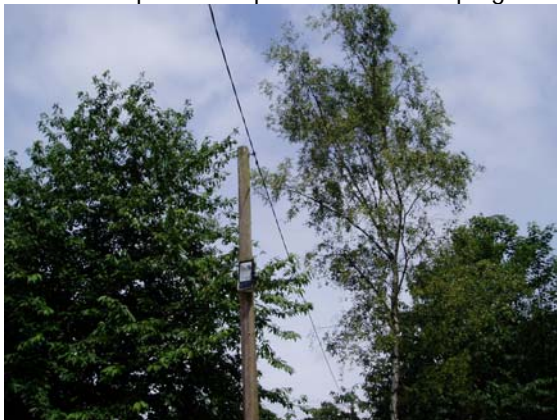
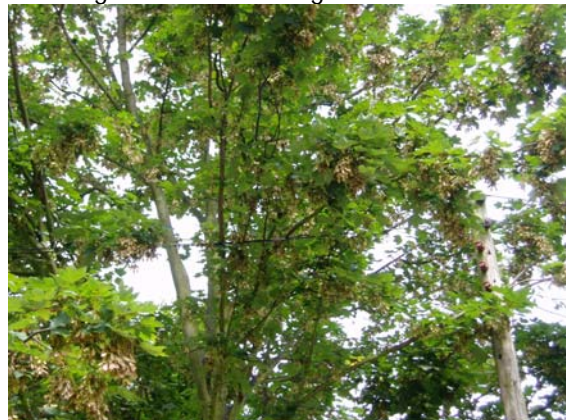
35.1 Further beyond the northern driveway, the land rises by approximately 1.5m and is a former burial ground. This area is grassed and planted with trees: rowan, sycamore, beech, cherry and a Christmas tree. The sycamore tree directly to the north of the church is planted quite close to the overhead cables, which is the incoming electrical supply to the church. I suggest that you have this tree crown pruned to prevent it from impinging on the wiring and cause damage in future.

35.2 The same comment applies to cherry tree at the end of the road where the telephone cable is just a little too close to the tree. Although not a problem at present, it may well be in future.

- 35.3 The sycamore close to the barrier gate has a branch leaning on the cables, this needs attention immediately. (*These items have been attended to since carrying out the QI.*)
- 35.4 To the west of the area laid to lawn, there is a small, low level boundary wall which leads onto the conservation area which has been left for wild flowers to develop. There is an avenue of silver birch trees here which are now quite mature and three yew trees within the grounds. This is an ideal place to encourage wildlife, bats in particular, as an alternative roosting place for them. I suggest you get in touch with your local bat worker for advice as where best to locate some bat boxes as they need to be placed in particular areas which suit the bats at different times of the year and for different weather conditions.

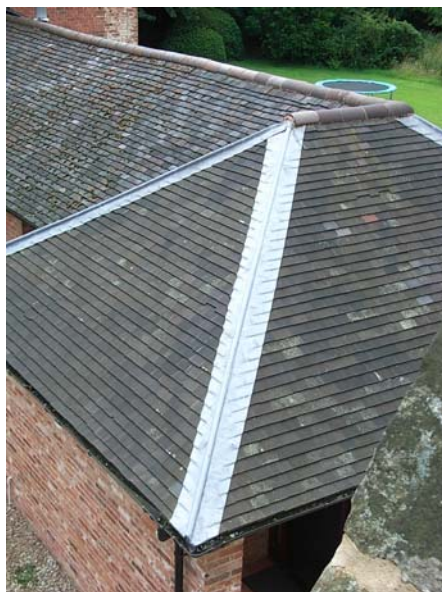
- 37.1 The Meeting Room is a small outbuilding which lies close to the east side of the church approximately 3m away. It houses the boiler room for the church and incorporates a disabled toilet.
- 37.2 This building has a hipped roof with lead hip rolls. The lead on the roof is in one length from the eaves to the ridge and this appears longer than the current recommendations. At present there is no evidence of cracking and I would not worry about it until it does start cracking and replace it at that stage.
